Willunga Main Street Project

Post Implementation Review & Critique

Friends of Willunga Basin

May 2018

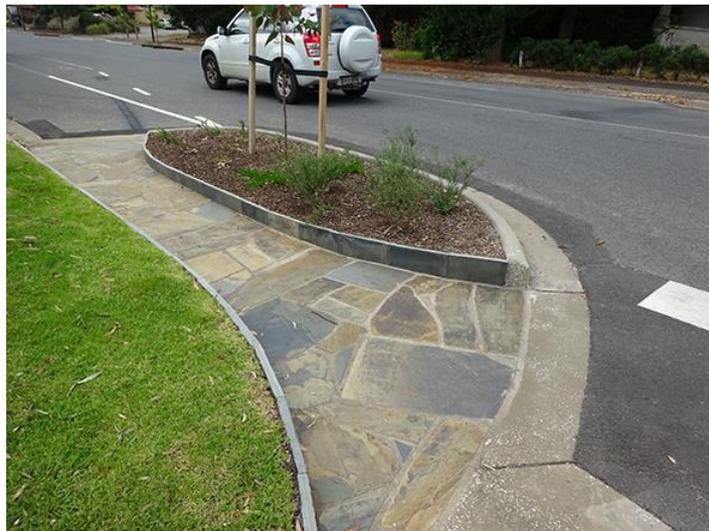
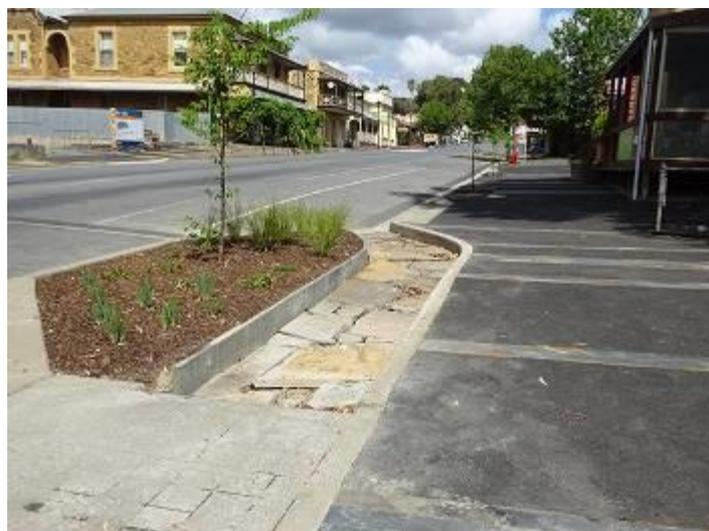
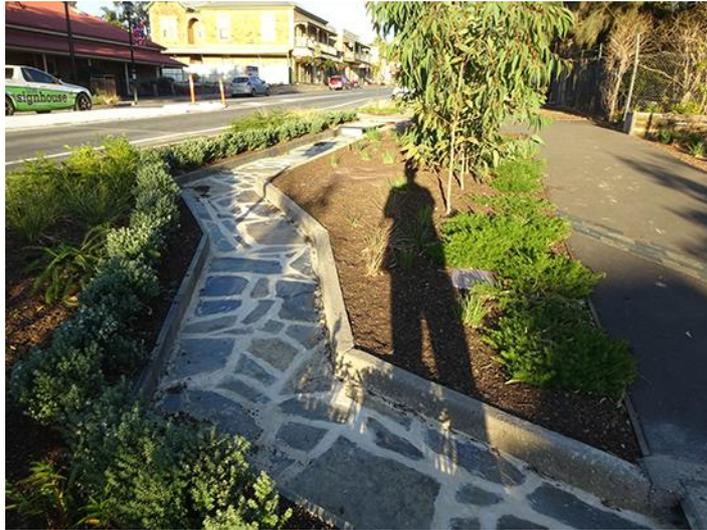
Random use of shapes for planter beds

Curved gutter form in some places, linear and angular in others

Mismatch between slate floor (substantial) and sides (light weight and small/bitsy)

Vertical slate is 'tile like' and more suitable for the domestic than public space

Horizontal slate 'crazy pave' pattern is out of context, more domestic patio or driveway than urban infrastructure (particularly in slate heritage area)

Inconsistent patterns of floor between various sections

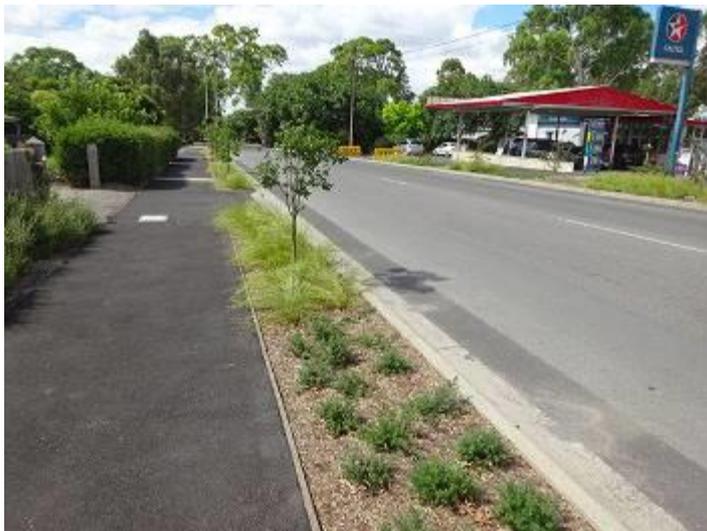
(Has softened with age)
Planting adjacent kerb where car parking possible makes passenger access difficult and plants will be trampled

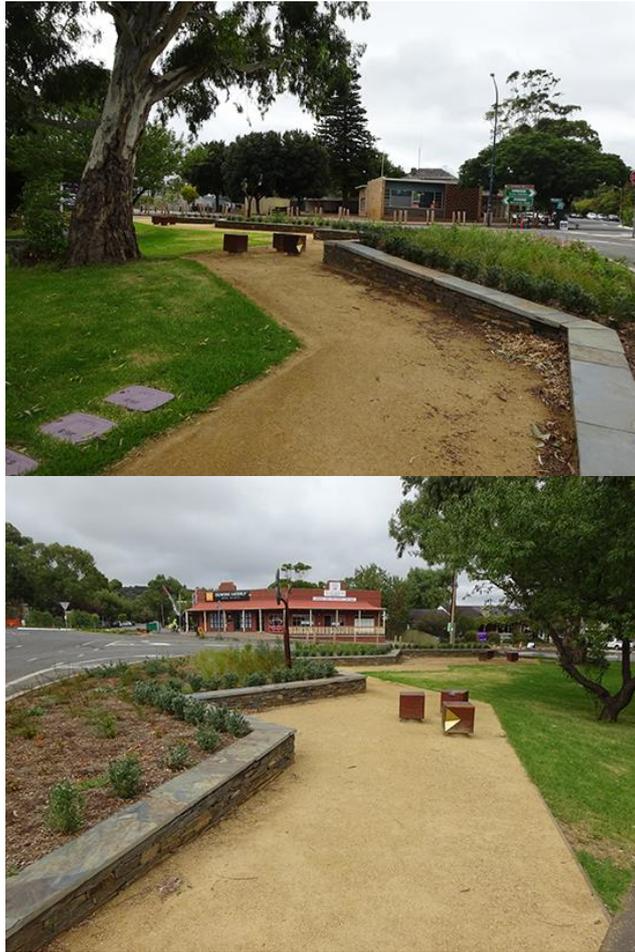
Angular planter beds, footpaths and walling on main corner are out of context and visually confusing. Takes away useful space in the park.

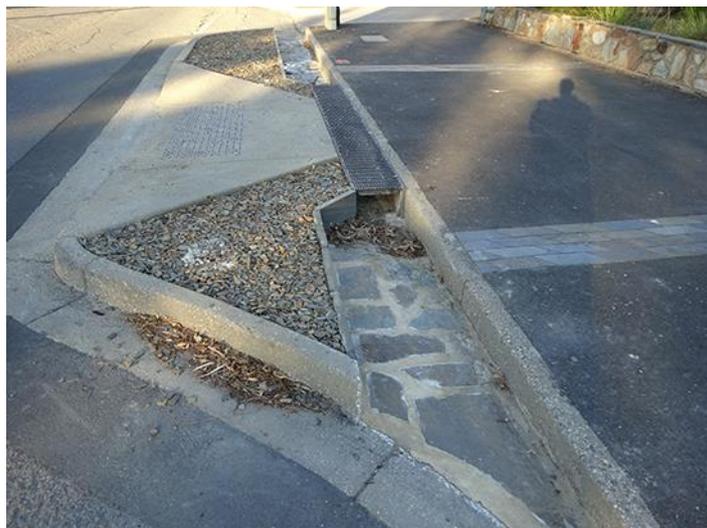
Different gutter crossing (plastic grate) and mulch (crushed slate) introduced at Aldinga Road

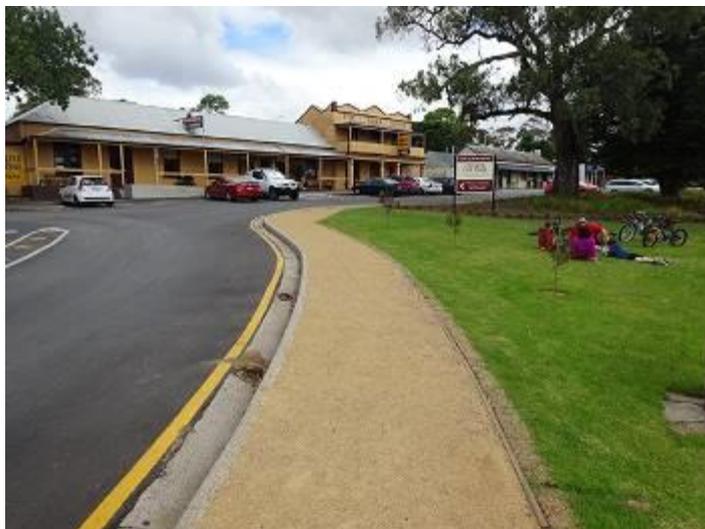
Random changes from curved linear path edges of uniform width to straight/angular edge is unnecessary and confusing (Alma Hotel)

(This area has now been used as a planter bed)

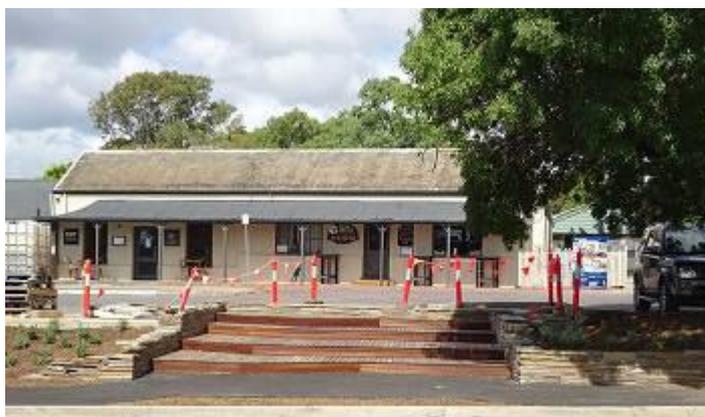
.Angular steps at market area are totally out of character and a post-modern intrusion

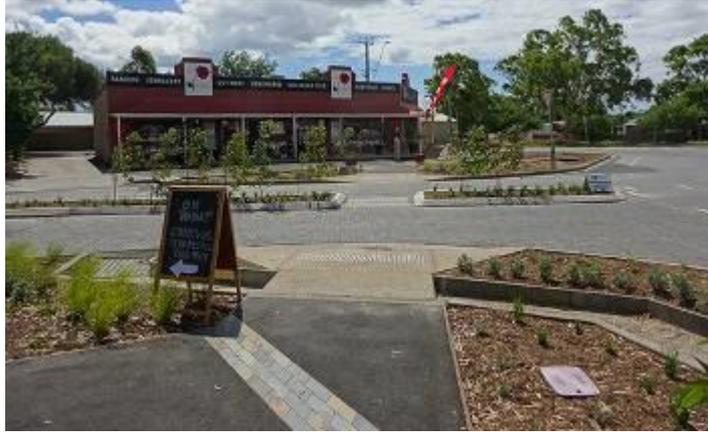
Crossing at main corner is visually confusing. Sight barrier of trees in median strip unnecessary for both vehicle drivers and pedestrians. Even more confusing for international visitors with reverse traffic direction.

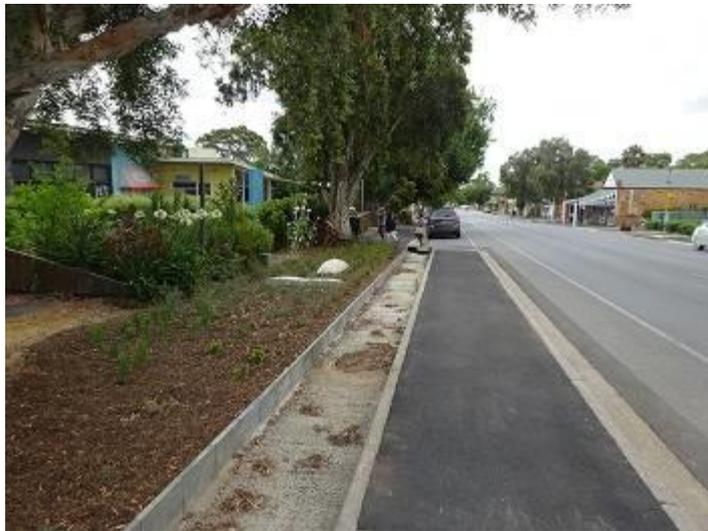
Random step out of path disturbs linear perspective of main street, creates unnecessary garden bed and takes away car parking potential.

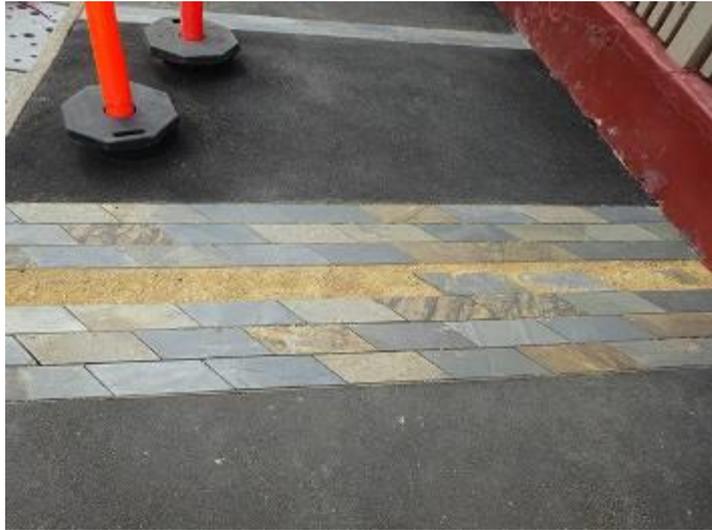
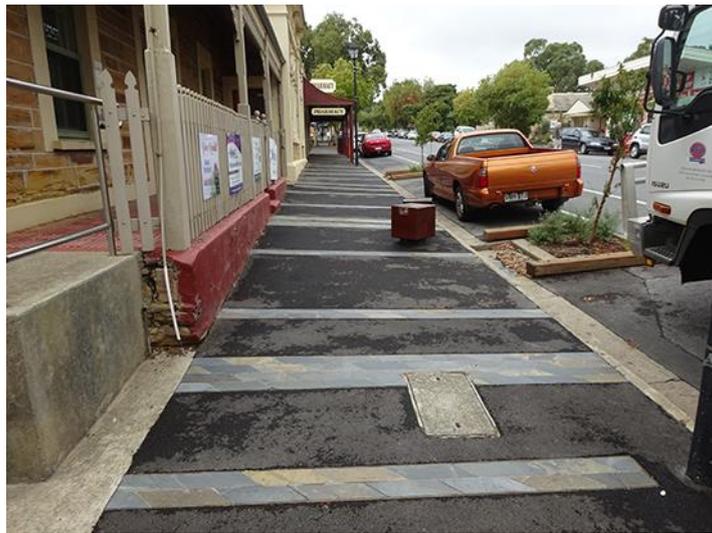
Strips across footpath disturb the linear perspective of Main Street and the long distance casual view

Creates a long 'zebra crossing' effect

Slate strips too bitsy as well as labour intensive and expensive. Geometric shape is more of a roofing pattern rather than a paving pattern and therefore counter intuitive. The angle cut has not grounding/context

Slate paving is traditionally substantial, not bitsy and decorative

- removal of all dolomite footpath strips and replace with bitumen – and, where strips are close together, remove and replace section to reduce the number of patches;
- adding timber boughs or similar to car parking timber sleepers as per existing example to make them visible to motorists, to soften the harshness and to add visual interest;
- growing vines and creepers on incongruous post and wire fences to disguise them;
- removing planting beds adjacent vehicle parking kerbing and replacing them with something suitable; and
- adding 2 or 3 large scale (locally sourced) slate slab features, as per the National Trust directional sign, to better reflect Willunga's slate heritage and provide greater and more appropriate visual interest.

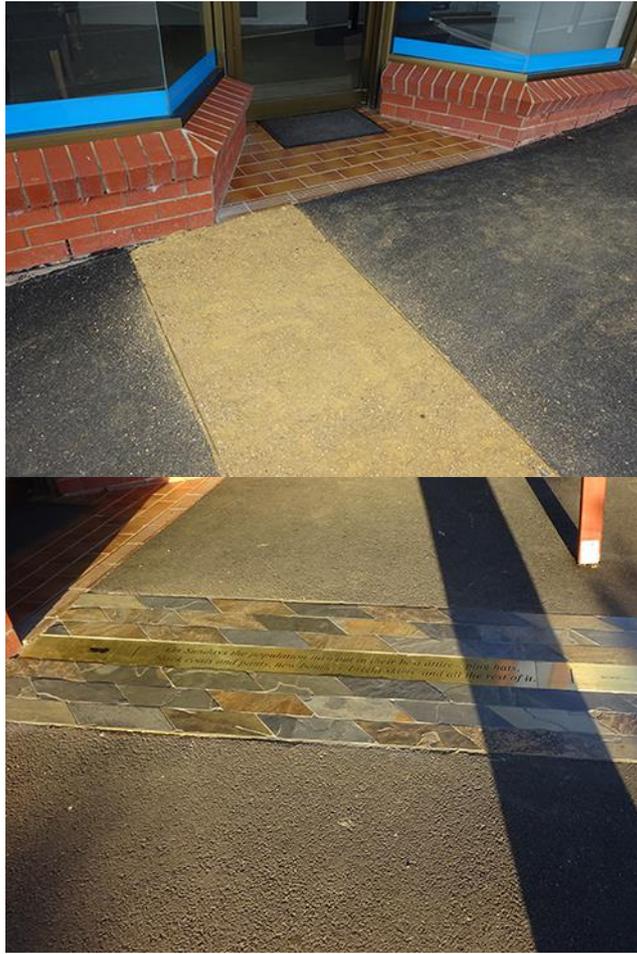
Random placement of slate strips in relation to existing built forms confusing (photo work in progress)

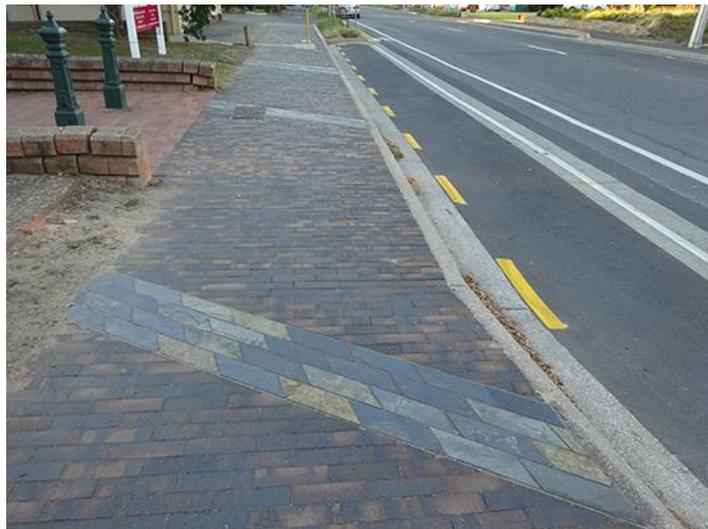
Random change from strips at right angle to built forms to angular

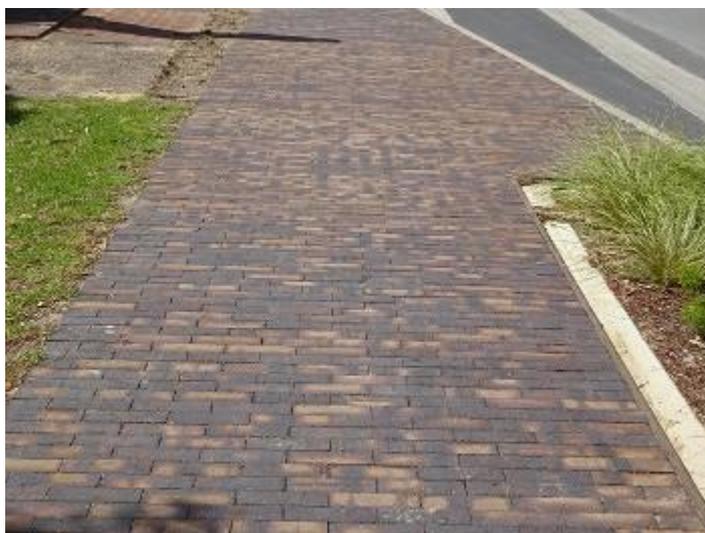
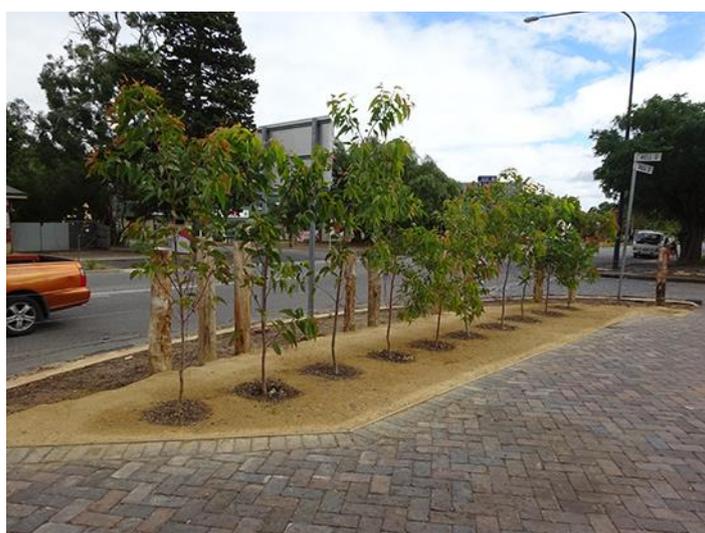
Willunga Hotel (Middle Pub) footpath is brick paving, while the opposite side of the road is bitumen

Pavers on the flat used on one side of the street, pavers on edge used on the other side

Surface patterns contradict, do not complement existing (e.g. in the market area)

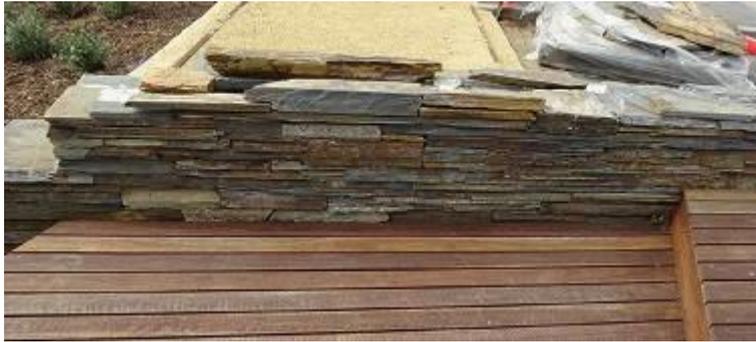
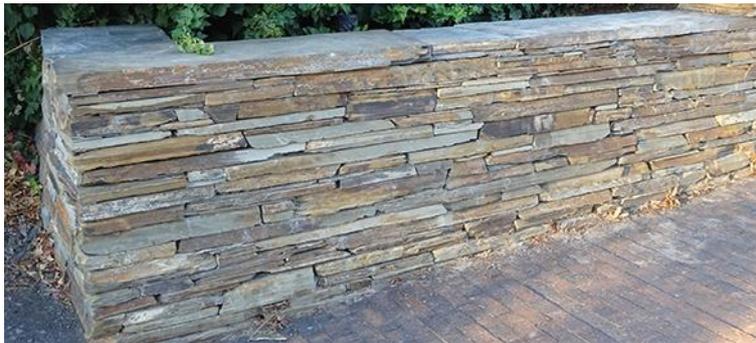
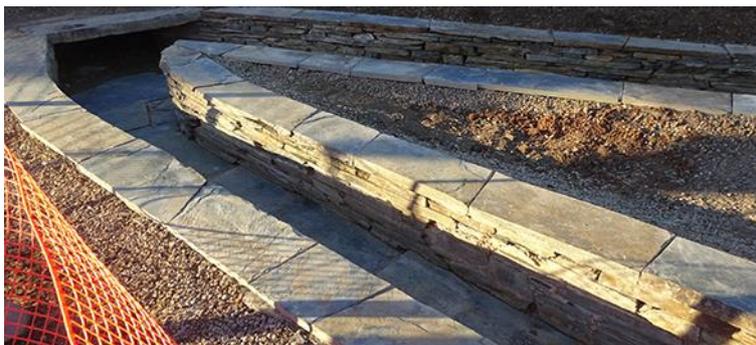
Slate walling is sometimes constructed of small/thin pieces of slate, bitsy and labour intensive

The private (?) slate wall adjacent Old Bush Inn is more substantial and reflective of Willunga slate walling.

The historic drainage channel gives indicator of robust nature of slate walling

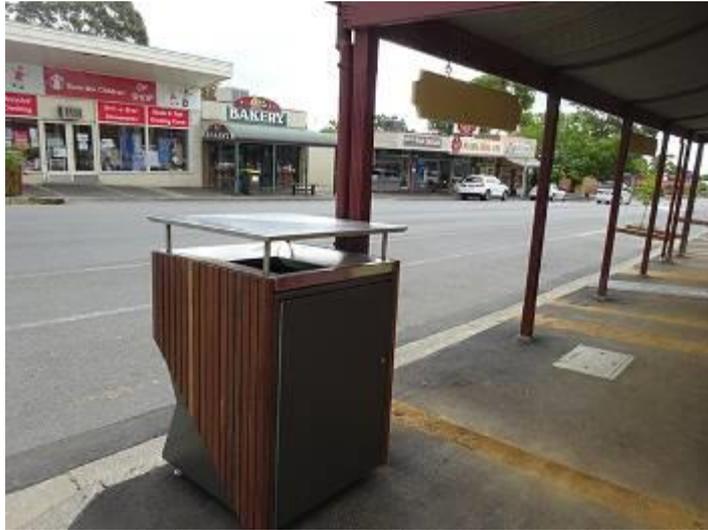
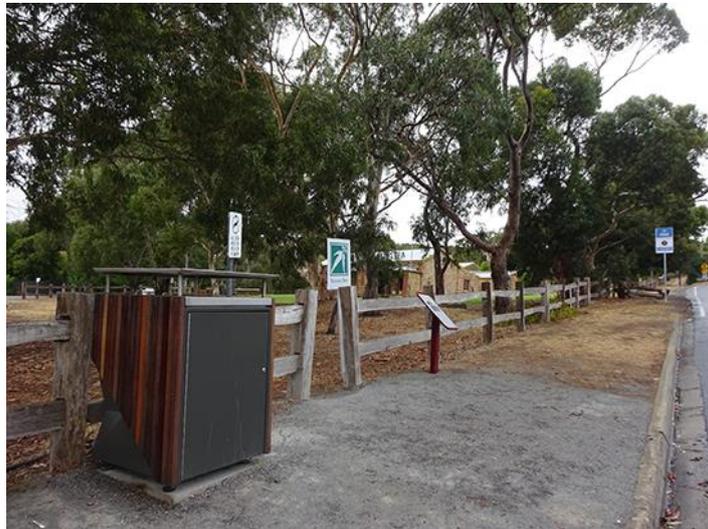
Bins are too large and imposing, while the cut-outs have no design context and are unnecessary (Postmodern - inner urban). No provision for recycling.

Bin positions awkward Maintenance of lower veranda post not possible in the example below. Conflict of character adjacent the Court House.

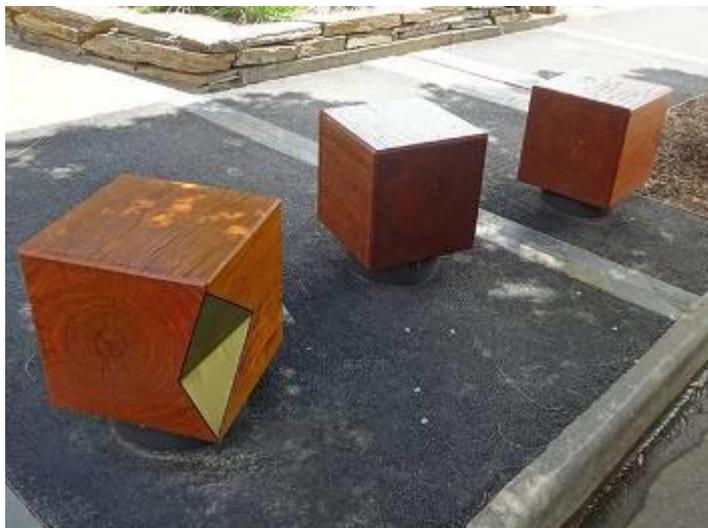
Timber seats, cut outs have no design context and are unnecessary (Postmodern - inner urban)

Timber seats are not readily seen at night and present a trip hazard

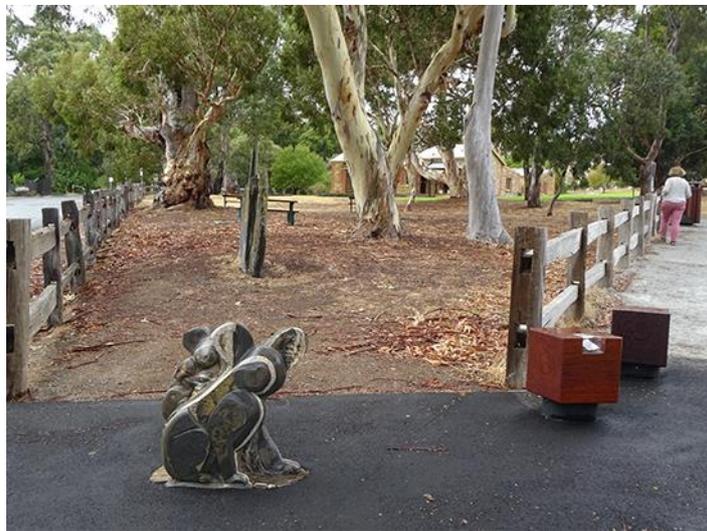
The multi-unit approach diminished the potential for a signature and memorable statement about Willunga.

The 'indigenous flora and fauna' theme is generic and making a kangaroo and koala of slate has no real statement about this place, particularly as koalas are not indigenous to the Mount Lofty Ranges. Public art theme is stated to be 'indigenous flora and fauna' but the koala was found only in the lower south east pre-settlement (DENR, n.d). It is an introduced native species from the eastern states (like Lemon Scented Gums).

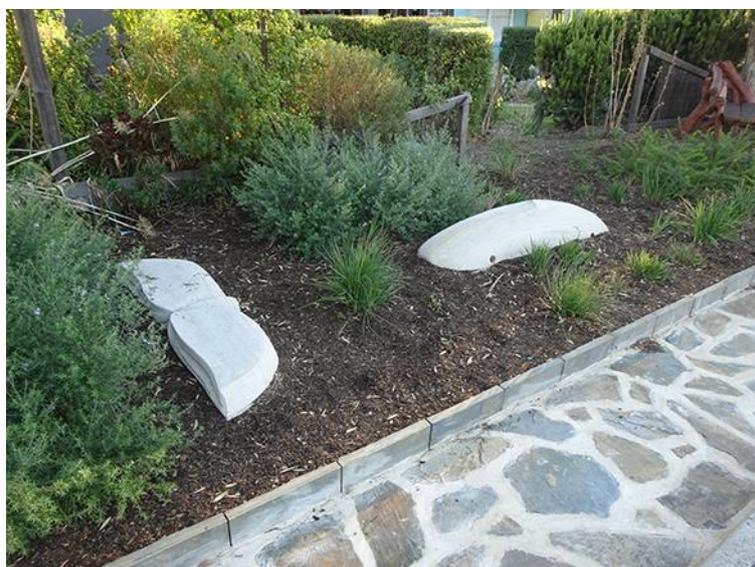
(Protruding metal leaves have apparently been rounded)
The whale marooned in a planting bed is completely out of place and will soon be lost as vegetation grows. Placement has no context

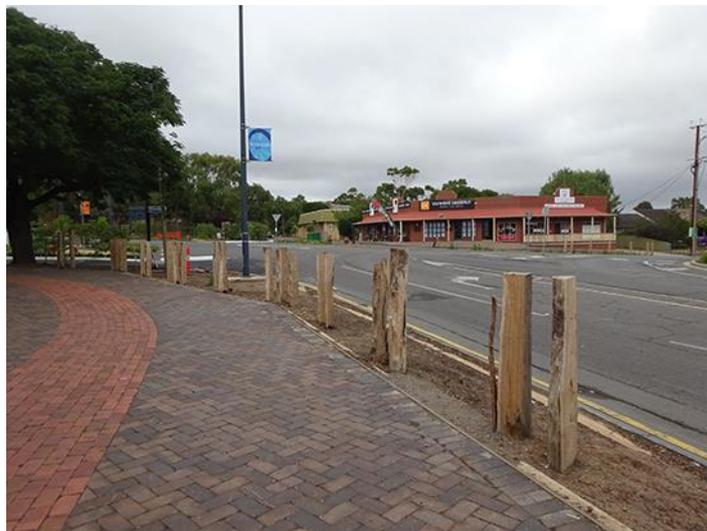
Pattern of timber fence posts has no design or historical context

Split post and wire fence is of a rural nature, not a township. Township would be cut/machined post

Outcome is neither one thing or another

Wire not robust or visually strong enough, already damaged in sections and difficult to see and hazardous for cyclists or pedestrians (who could fall 'through' and get trapped or garrotted)

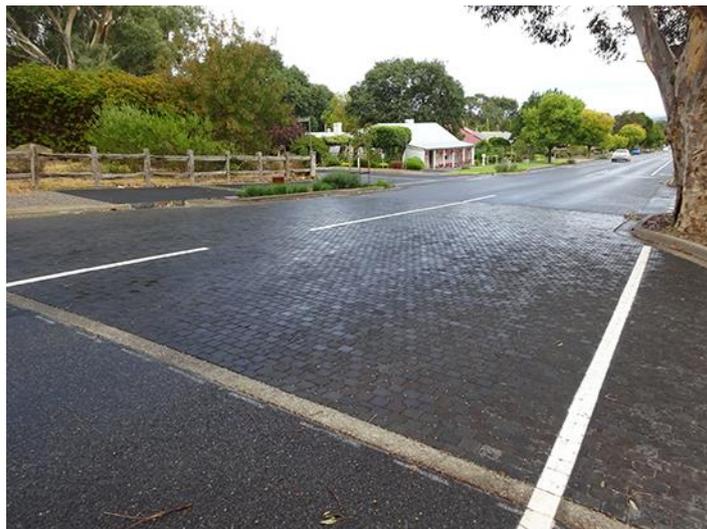
Use of 100mm cobbles in road has created another (expensive) design element that lacks cohesion. Why use them?

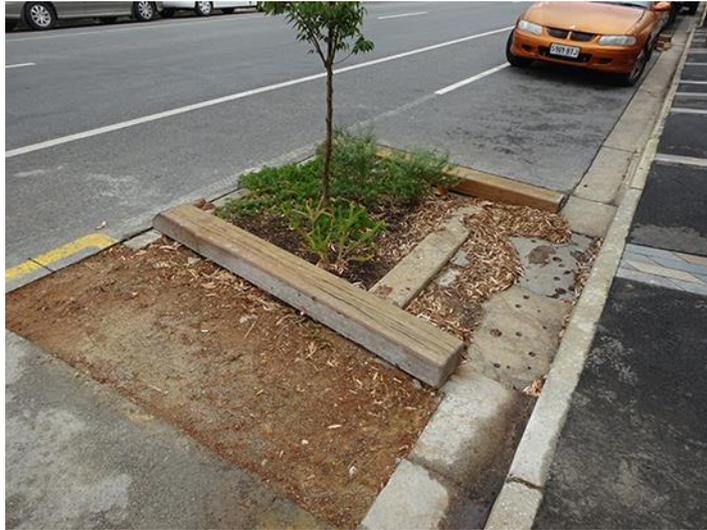
The timber sleeper wheel stoppers an awkward protrusion and not usually associated with a main street car parking structure. Sleepers are clumsy and will age ungracefully

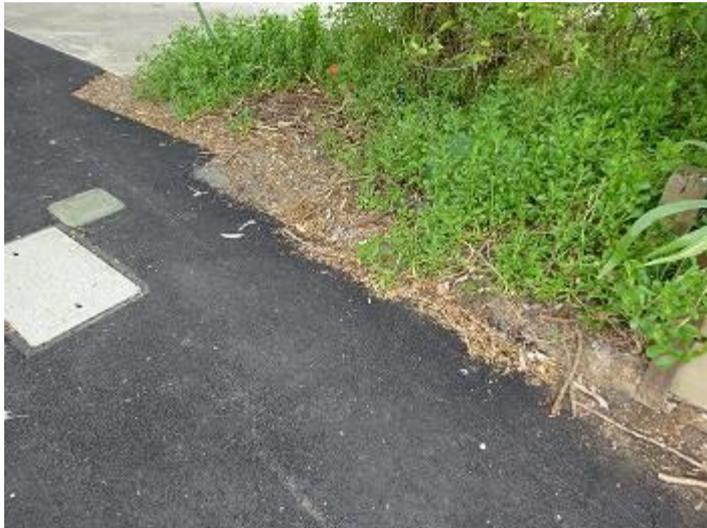
Clumsy bitumen edging to some property boundaries

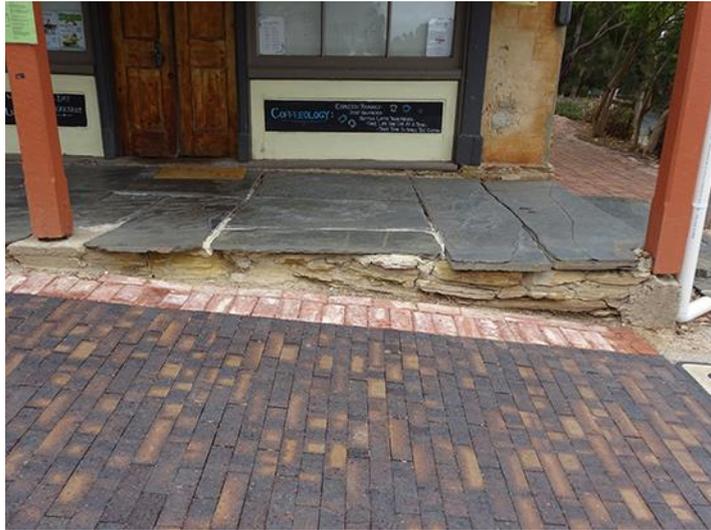
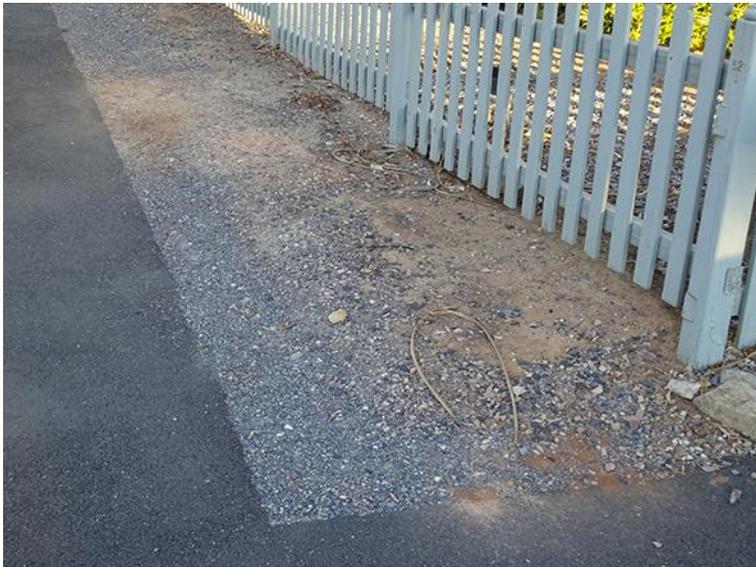
Unresolved boundary edges. Change in paving level has left several unresolved vertical edges. 'No-man's land' in front of some domestic premises. Given the \$3m budget for the project, the resolution of these eye-sores with the property owner would have been logical

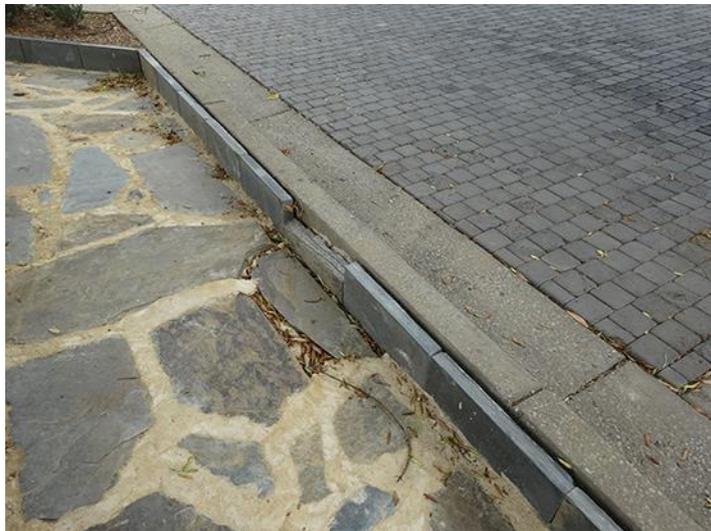
Slate tiles in drainage channels already broken/fallen off in some areas

Concern that vertical slate tiles may delaminate over time, no protective capping
